6-19-14

Pebble mound along  
bar at mouth of Portage Cr.  
→ Sus. in

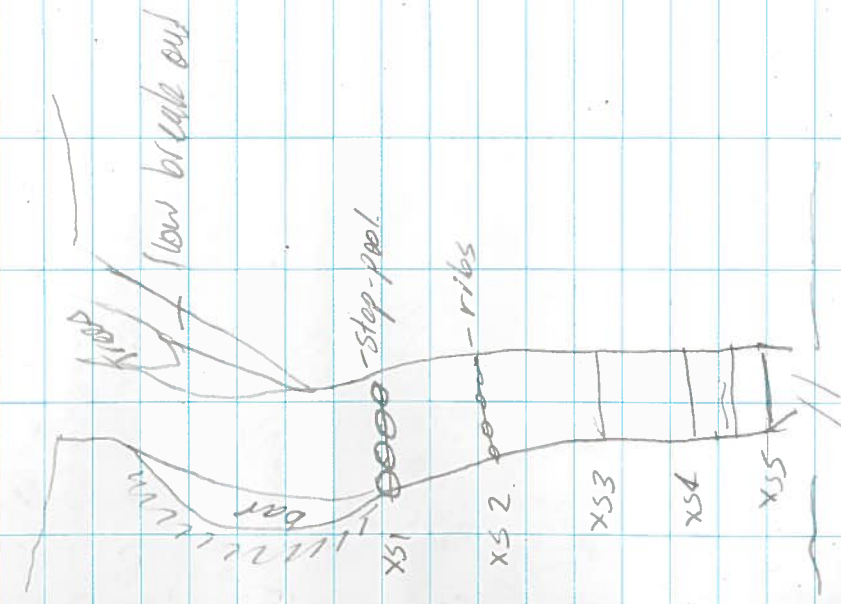
- Representative XS's
- all XS's are very similar.
- uniform reach.
- plank - bed reach.
- stop-pool at XS1
- most stop-pools located b/t confluence - XS1.
- well away from RR right of way.
- XS1 -> S located on plank bed, with ribs starting to ~~even~~ evenize.

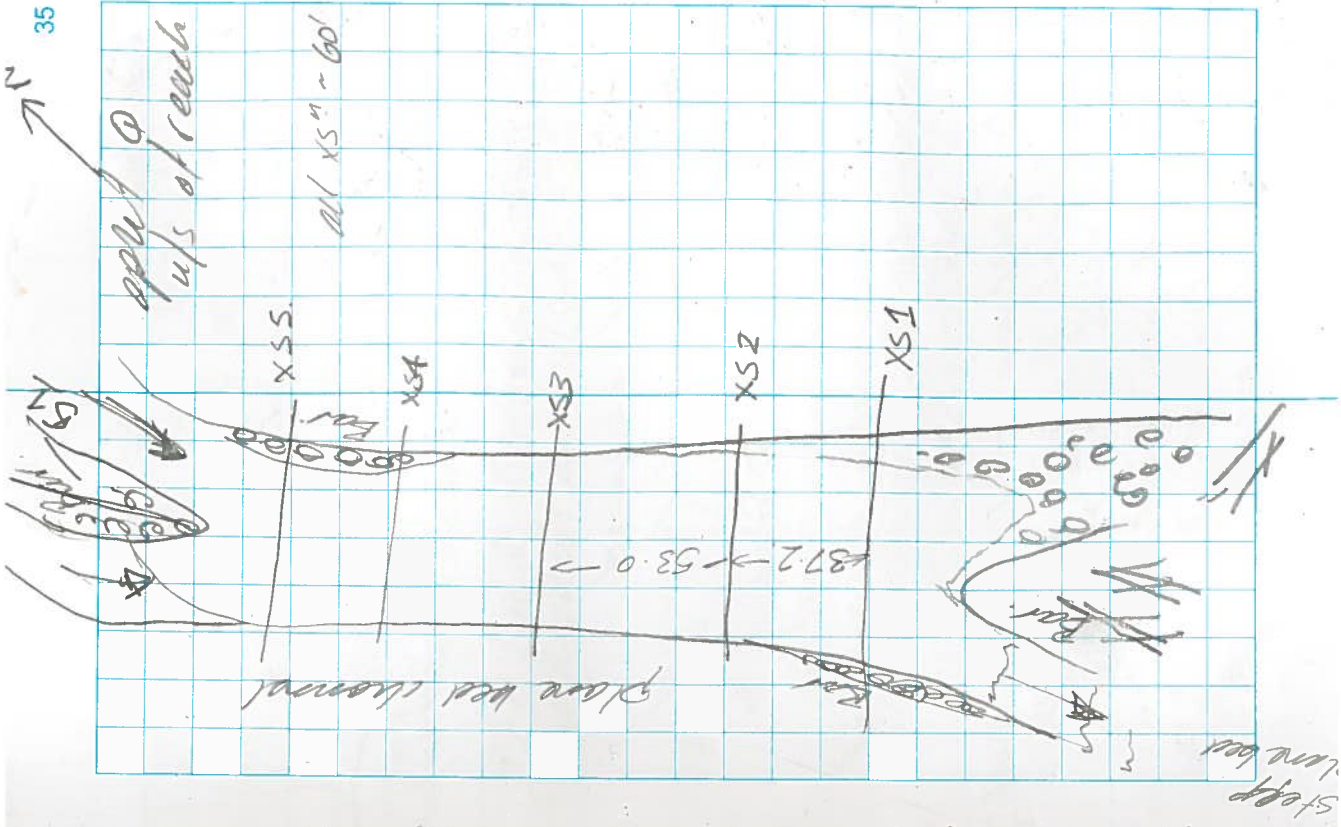
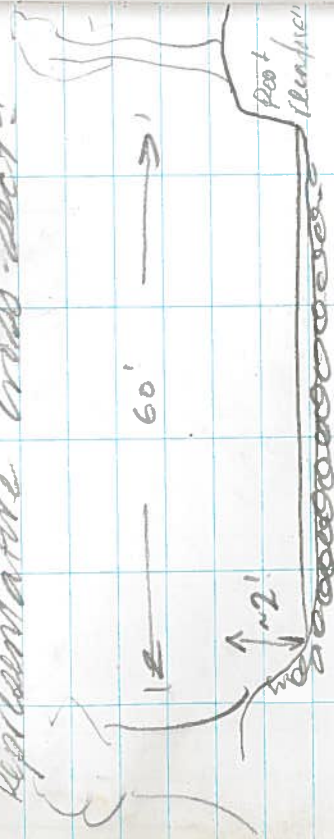
Representative cross-section

- plane bed channel.
- no sand  $\rightarrow$  boulder sized material
- no step-pool in reach
- all cross-sections ~~are~~ have reasonably consistent geometry.
- XS<sup>1</sup> spacing  $\sim$  1 chan width.
- could not find longer reach
- this reach, all flow contained in banks.
- bank reasonably low  $\rightarrow$  drop off over bank ~~to~~ of bank.

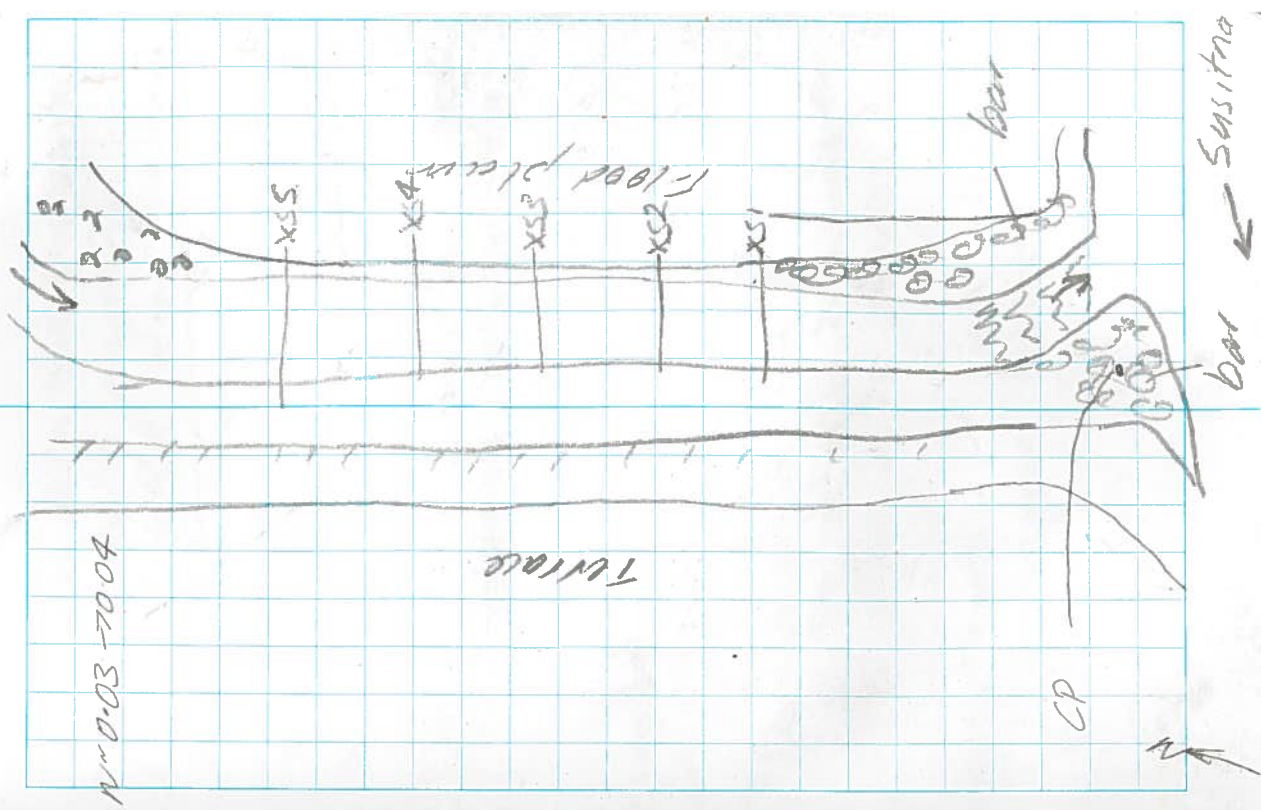
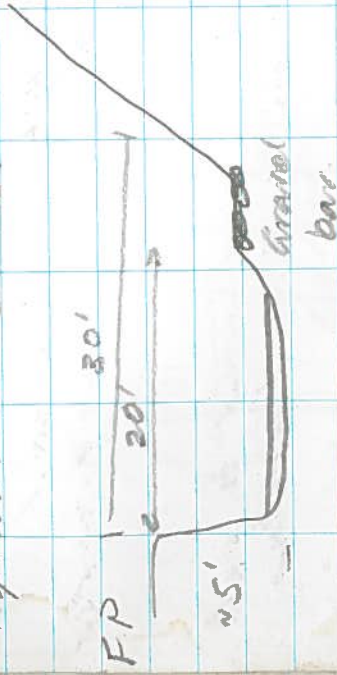
Representative XS.

- plane bed channel.

evidence of large flood event (2012?) possibly across flow

- large flood deposits - boulders up to 4' up of reach

- study reach ~~reasonably~~ straight & reasonably uniform.

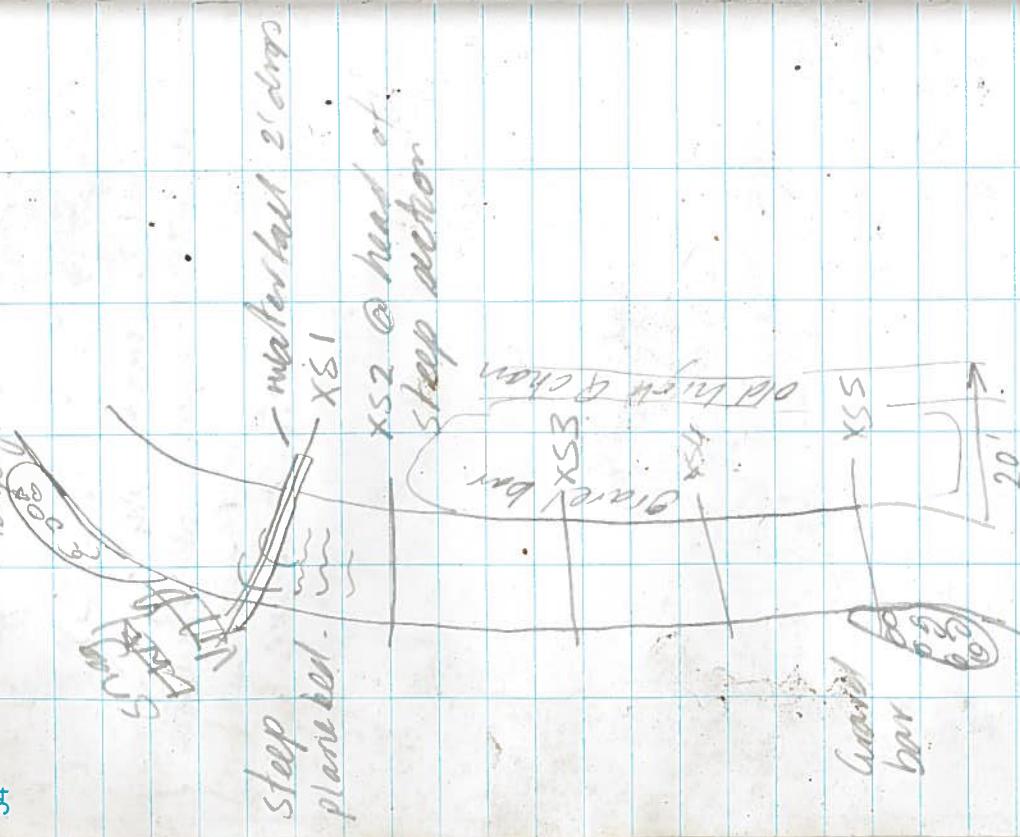
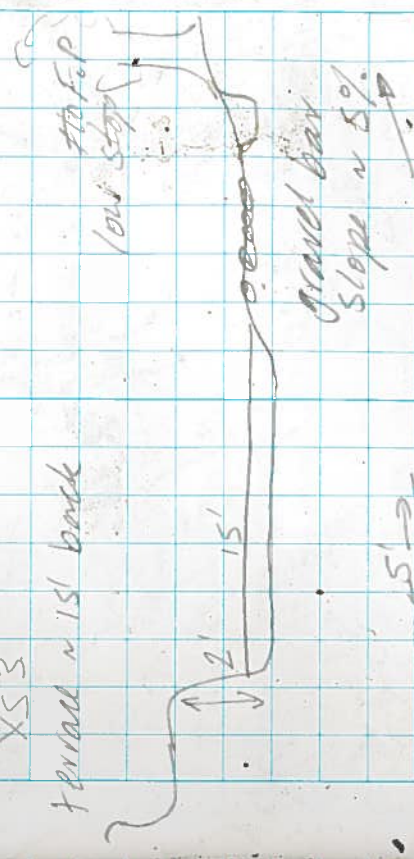
XS3 "XS 4 in straight action, likely best representative actions XS5 - has small gravel bar along left side"

- wash strip
- influence of recent large flood.

XS3  
ferrad ~ 15' back
