RAV FIELD BOOK  
2014 - #1

Address *Tetra Tech*

Phone *Geomorph Studies*

Project *8/8/14 - 8/14/14*

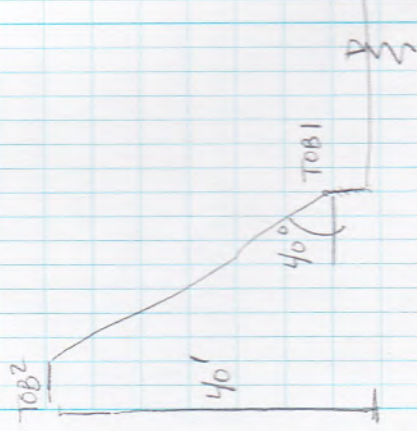
VR-1-1 TLB

Est Mannings : 0.04 - 0.05

Est V :  $\sqrt{\frac{mi}{h} \cdot \frac{5280ft}{m} \cdot \frac{1}{3600s}} = 5.9 ft/s$   
 (measured mph) w/ Garmin floating d/s  
 V seems high, may have had extra speed from pushing off-shore

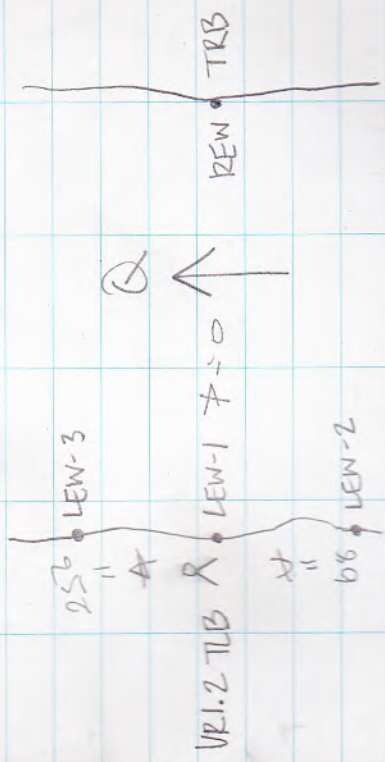
TRB c UR-1.2

Est n : 0.04 - 0.08

- short vegetation along near vertical bank face
- roof reinforced
- Surface continues to rise @ 15° moving inland
- Sparse spruce, small shrubs and willows
- ice paving @ toe

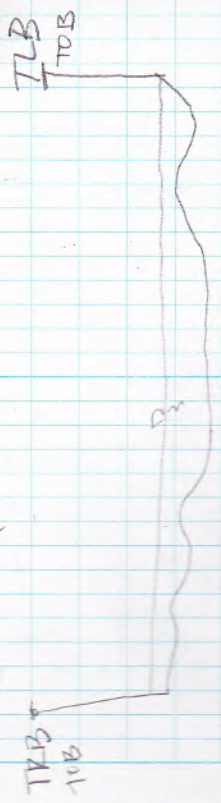
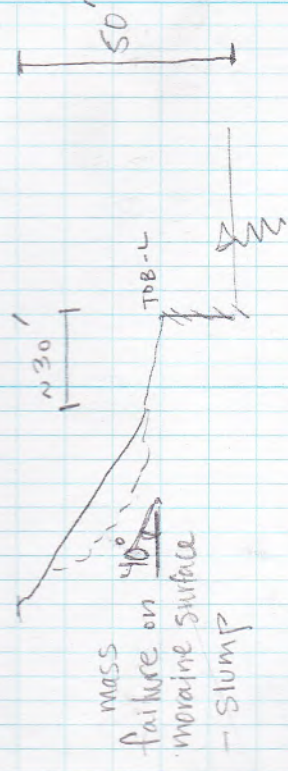
TLB

Bank is vertical - root reinforced, sedges  
Willows, alders, evergreens  
Slopes up moraine @ roughly 40°

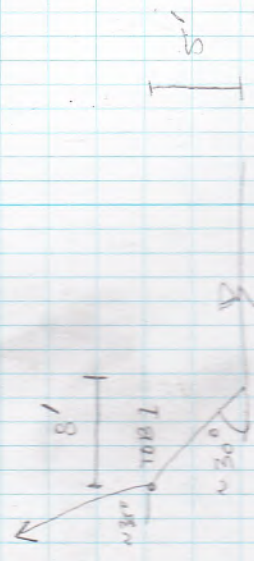
TLB - PROFILE VIEW D/S

FROM LEW TO TOB 1 no veg.  
 scoured - ice and fluvial  
 ice effects on trees - scars,  
 root shoving by ice  
 armored toe - cobbles and small boulders  
 slumping of moraine  
 small gravels deposited throughout bank  
 TOB 1 up moraine is vegetated,  
 roots, trees, grasses, cauliflower  
 near TOB 1  
 Approx 5' up to TOB 1 west  
 and 8' up to TOB 1 north  
 Est. n ~ 0.08

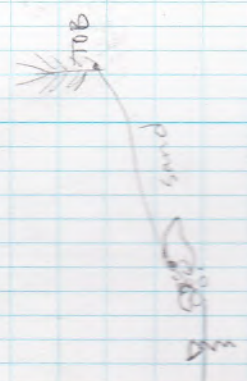
TRB - PROFILE      VIEW D/S

- Top of bank - armored with small gravels
- large gravels, cobbles, some boulders
- sandy upper layer
- short brush, trees @ TOP
- ice paving
- piles of drift wood @ TOP
- EST n. ~ 0.06 - 0.08

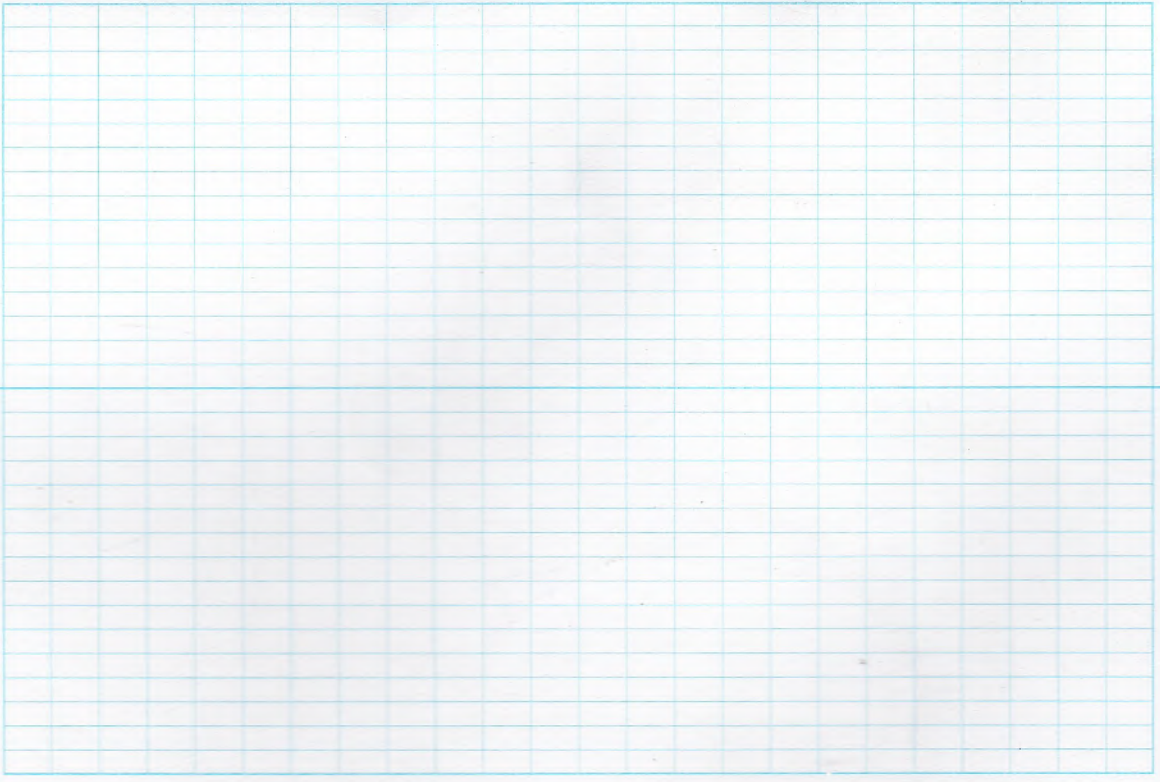
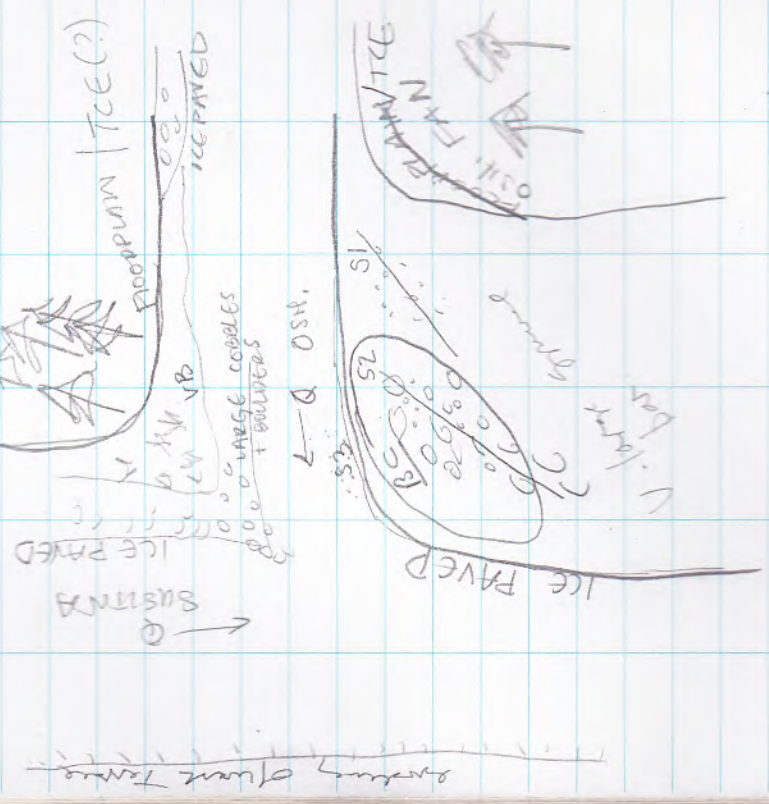
OSKETHNA

Mouth of Oskethna confined by Fan/TCE  
 Ice Scars ~ 10' above <sup>at least</sup> WSE  
 Plane bed river - Incised down into its fan  
 Heavily armored  
 Vertically stable  
 Significant sediment point source
