RAV FIELD BOOK
2014 - #2

Name **Renee Vandermause**

Address **Tetra Tech**

Phone **Geomorph Studies**

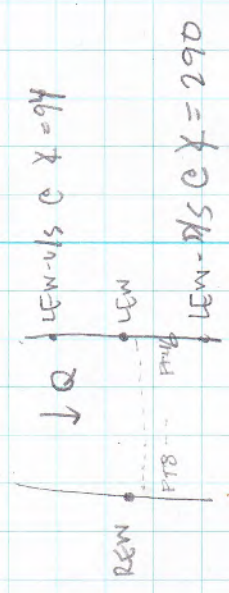
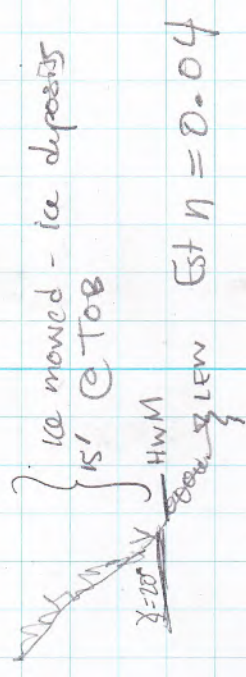
BIRD'S EYE VIEW

PT 1 = ICE PUSH LEDGE
 FROM PT 1 to Start of dense veg
 is about 15' vertically @ 20° slope

TLB \uparrow

TRB = Bedrock Face

Est $n = 0.04$

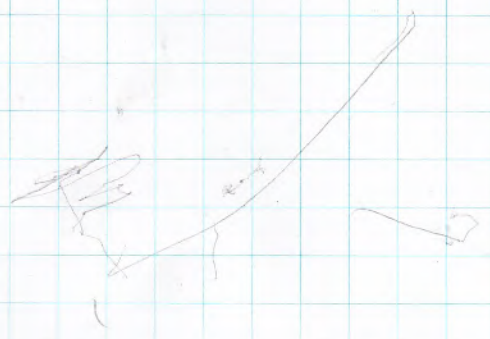
DEADMAN CK.

HUGE BOULDERS AT TOE OF BANK - derived from old fan ^{lag} deposits
→ ice paved

Fan surface ~~some~~ eroding but boulders @ toe maintaining constriction

Presence of fan, big enough to hold itself against bedrock constriction on other side

Steep lower profile held up by very large boulders - lag boulders from Deadman CK.
