OSHETNA

OSHEETA CONFERENCE

BAR SURVEY @ MOUTH

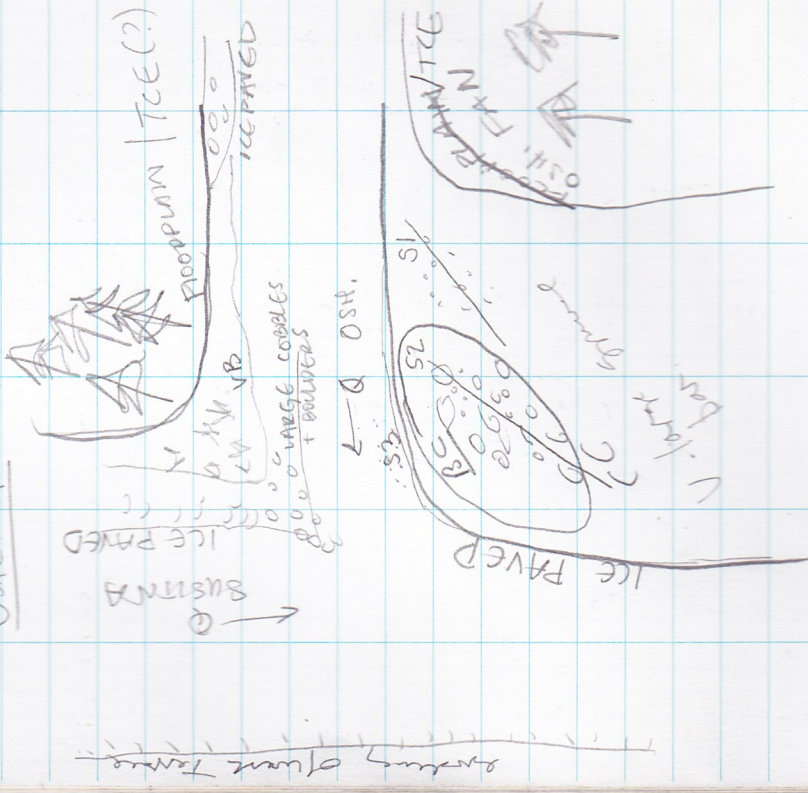
Mouth of Oshetna Confined by Fan/TCE
 Ice Scars ~ 10' above WSE
 Plane bed river - Incised down into its fan
 Heavily armored
 Vertically stable
 Significant sediment point source
