Date and Time: 8/26/14	Northing / Lat: 3028208.7
River: SUSITNA	Easting / Long: 1620635.6
X-Sec / PRM: 97.9	Bank Height (ft): 3.9' above WSE
Field Book #: -	Failure Mode: cantilever
Sampled By: MDH, BT, RV	Root Depth (ft): 3'
Comments:	Bank Angle (deg): vertical
Sample Number: S1

Bank Samples

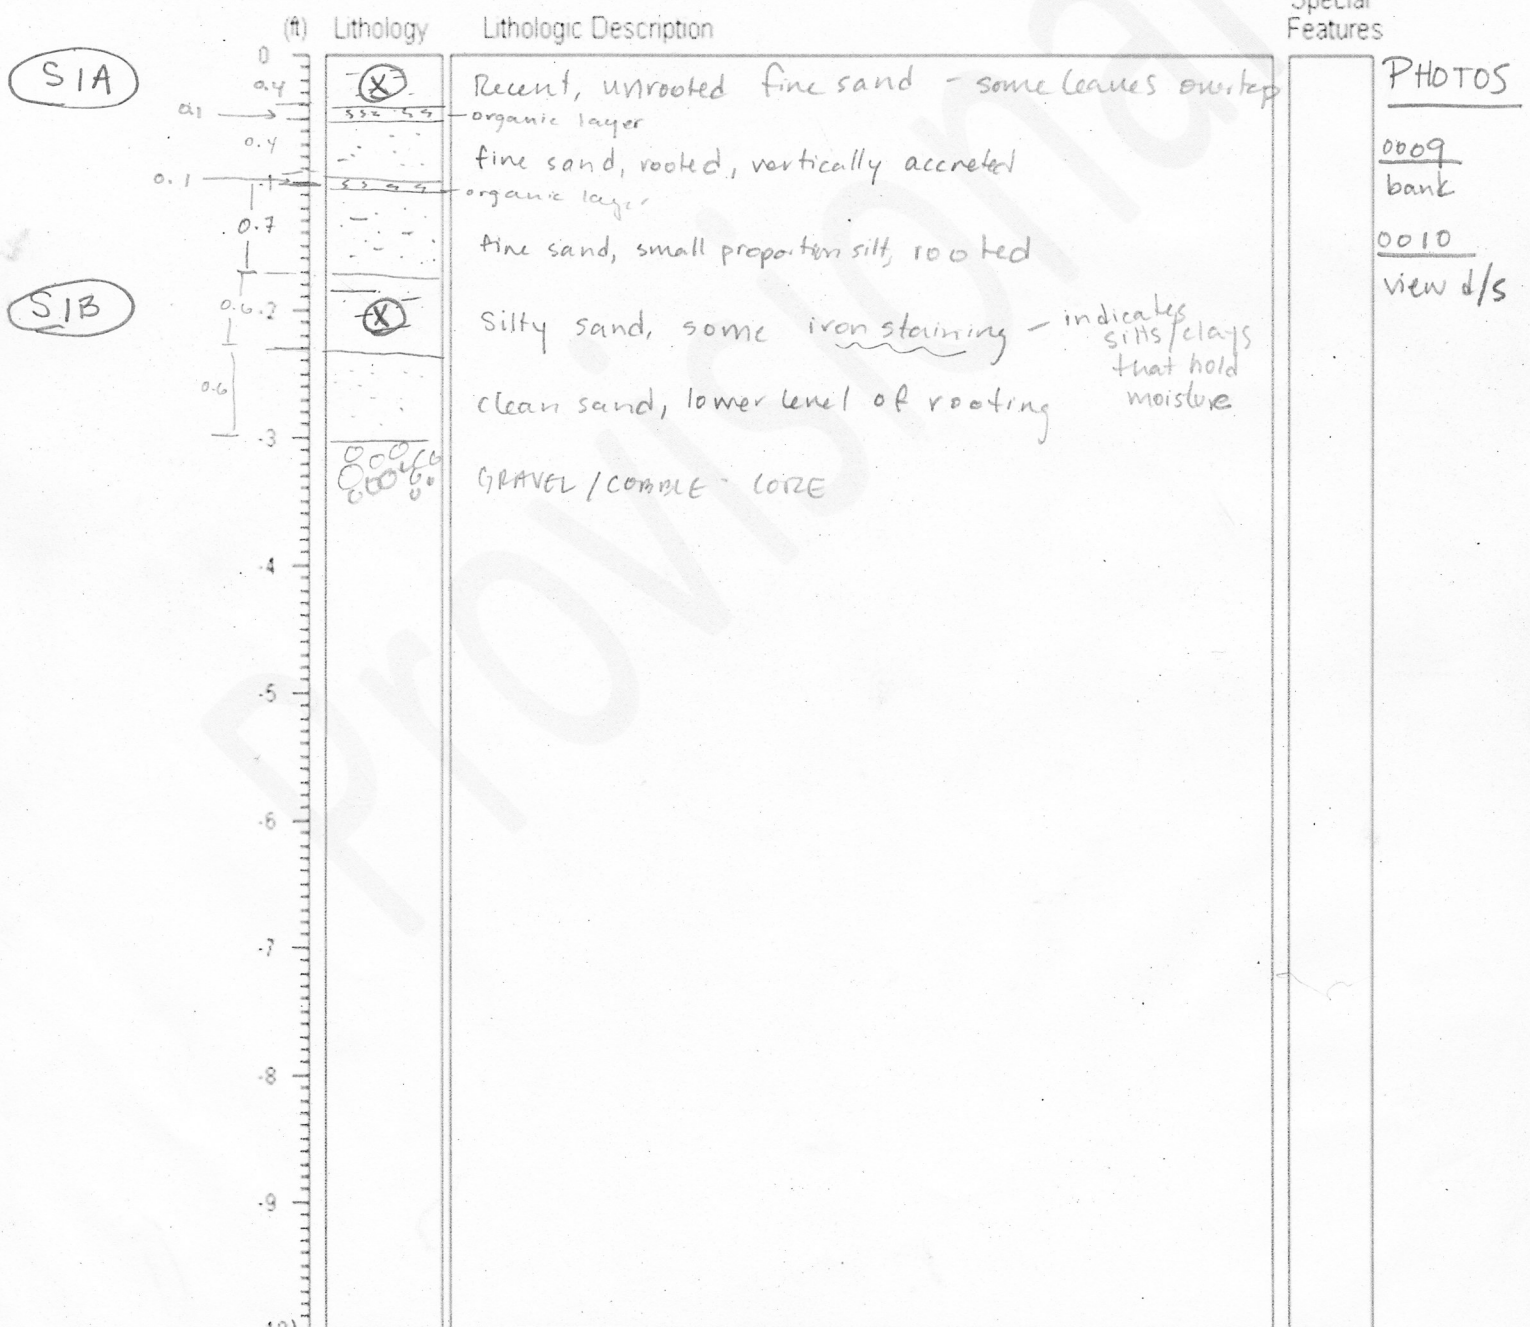
LR-1

Younger surface ~ YFP / VB	Recent sand deposition on
Alders ~ 20'	Entire bank eroding - undercut
Poplars < 0.5' ø	↳ roots holding bank in place
