Date and Time: 8/28/14 1000 Northing / Lat: 2832409.2  
 River: SUSITNA Easting / Long: 1608147.4  
 X-Sec /PRM: PRM 52.0 Bank Height (ft): 3.6' to base gravels; 5.1' to WSE  
 Field Book #: - Failure Mode: cantilever  
 Sampled By: MDH, BT, RV Root Depth (ft): 2'  
 Comments: Bank Angle (deg): vertical

LR-3

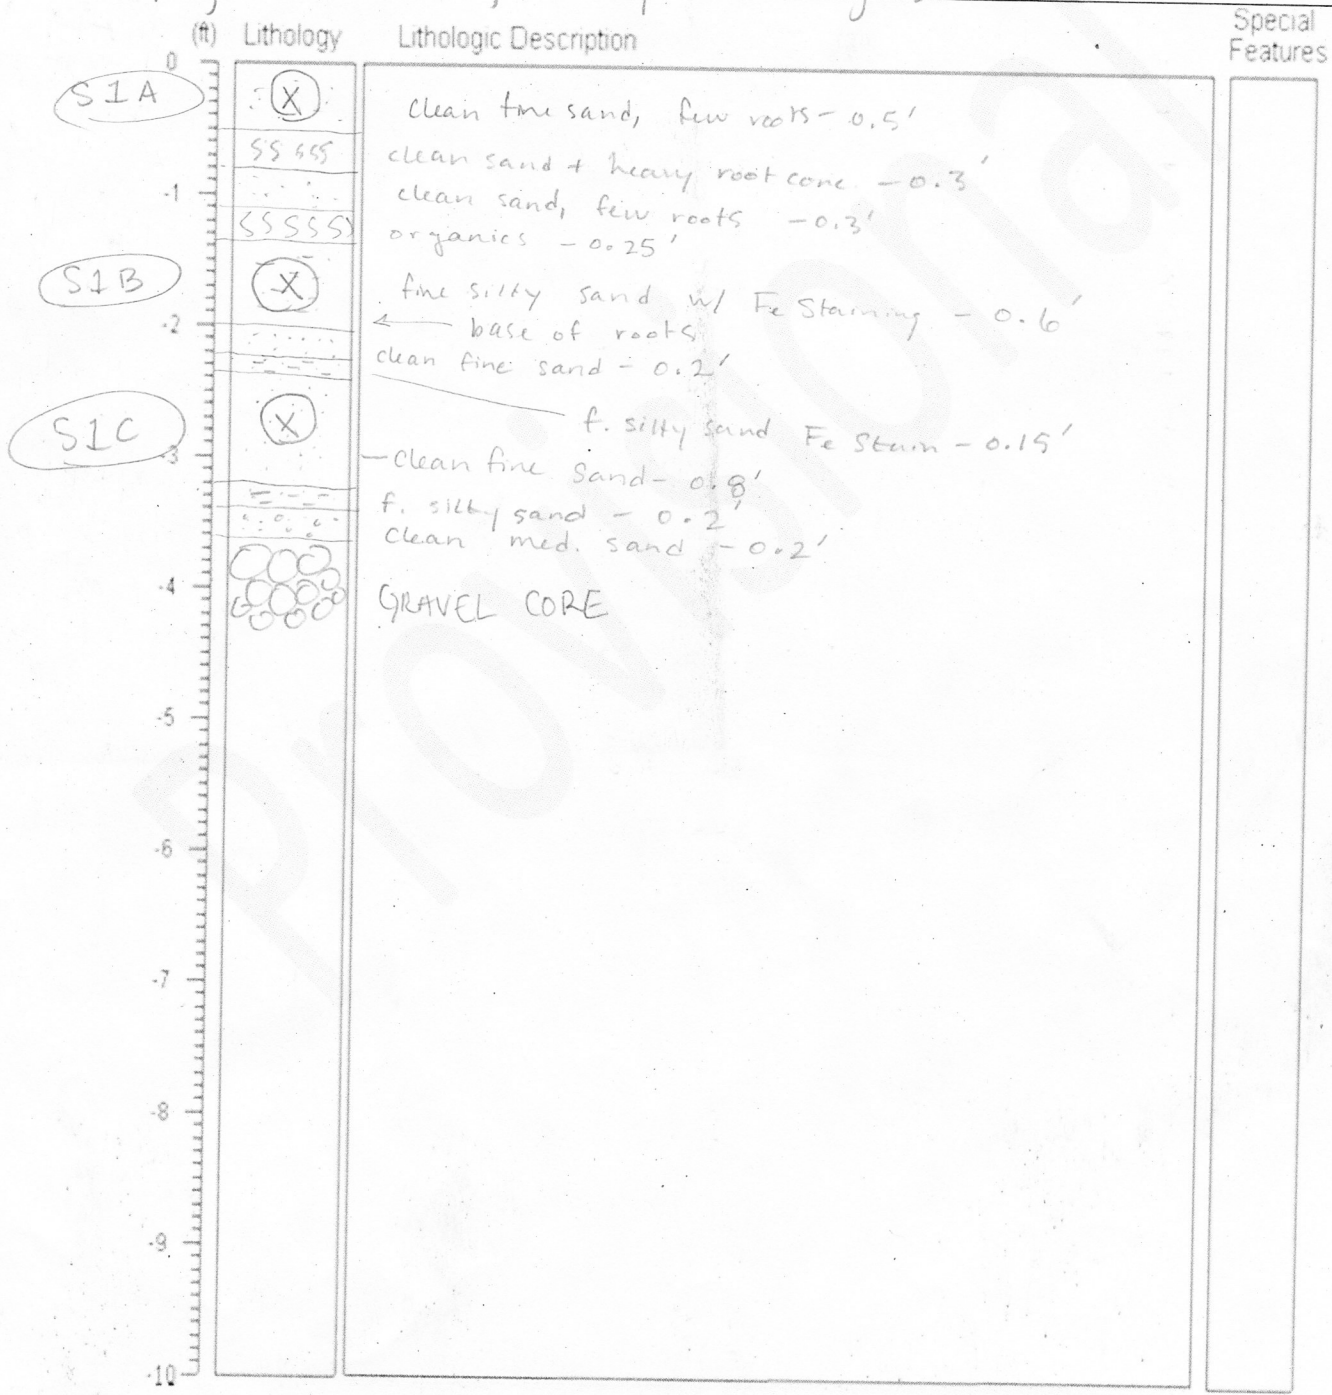
PHOTOS: 207-208 Bank Samples: 3 TOTAL -> S1A, S1B, S1C

Mature to old Floodplain Surface  
Recent sand dep. on top of surface. (2 fairly recent sed. events)  
Dying trees along floodplain margins
