6-19-14

Pebble mound along  
bar at mouth of Portage Cr.  
→ Sus. in

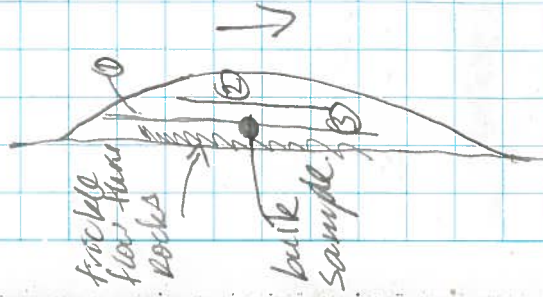
- laid out 3 100' tapes.
- not wide enough for 3 parallel frames
- bar ~ 8" above WSE
- unbricated
- uniform along length of bar.

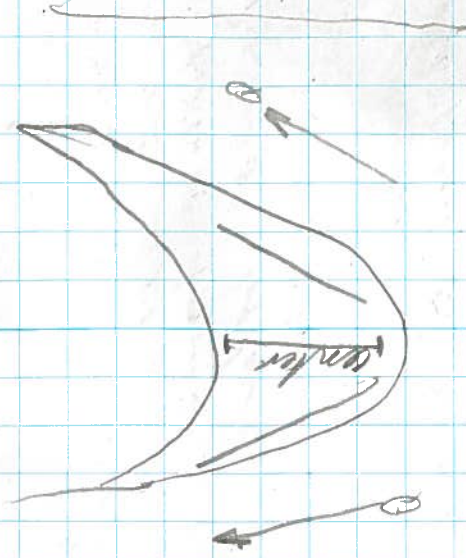
P158 Bilt / clay on over face  
P159 view of ice rafted  
boulders @ head of island.P160 \* towards u/s end  
of islandP161 Surface material  
at 50' mark on center  
transect

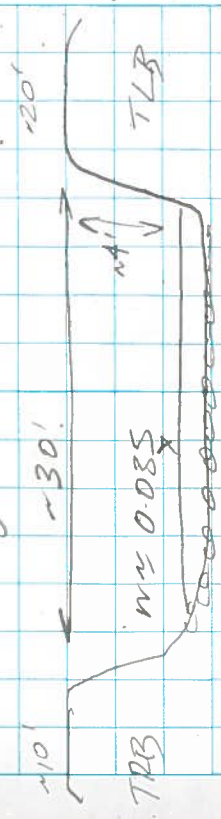
- Representative XS's
- all XS's are very similar.
- uniform reach.
- plank - bed reach.
- stop-pool at XS1
- most stop-pools located b/t confluence - XS1.
- well away from RR right of way.
- XS1 -> S located on plank bed, with ribs starting to ~~even~~ evenize.

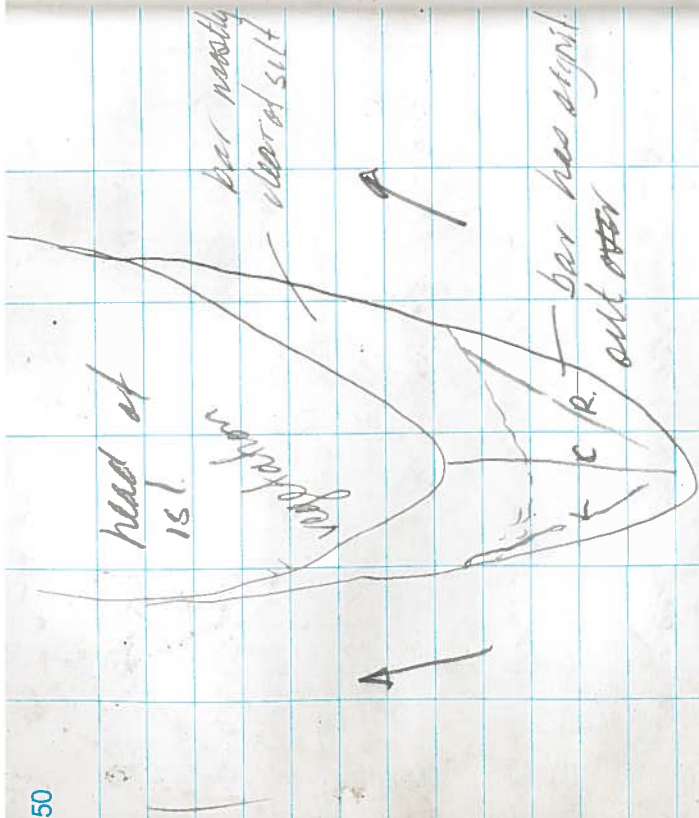
P304 \$ d/s along center  
 transect
