RAV FIELD BOOK  
2014 - #1

Address *Tetra Tech*

Phone *Geomorph Studies*

Project *8/8/14 - 8/14/14*

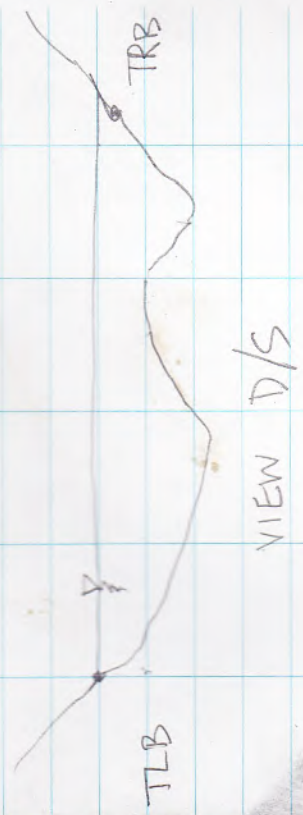
VR 2.1

TRB - PROFILE      VIEW D/S

- Top of bank - armored with small gravels
- large gravels, cobbles, some boulders
- sandy upper layer
- short brush, trees @ TOP
- ice paving
- piles of drift wood @ TOP
- EST n. ~ 0.06 - 0.08
