LR-3

Date and Time: 8/27/14 1430 Northing / Lat: 2838140.4
 River: SUSITNA Easting / Long: 1596781.2
 X-Sec / PRM: PRM 51.2 Bank Height (ft): 5' above gravels and WSE
 Field Book #: — Failure Mode: cantilever
 Sampled By: MDH, BT, RV Root Depth (ft): ~3'
 Comments: Bank Angle (deg): vertical
 P130 - Bank Bank Samples: 3 SAMPLES → SA, SB, SC

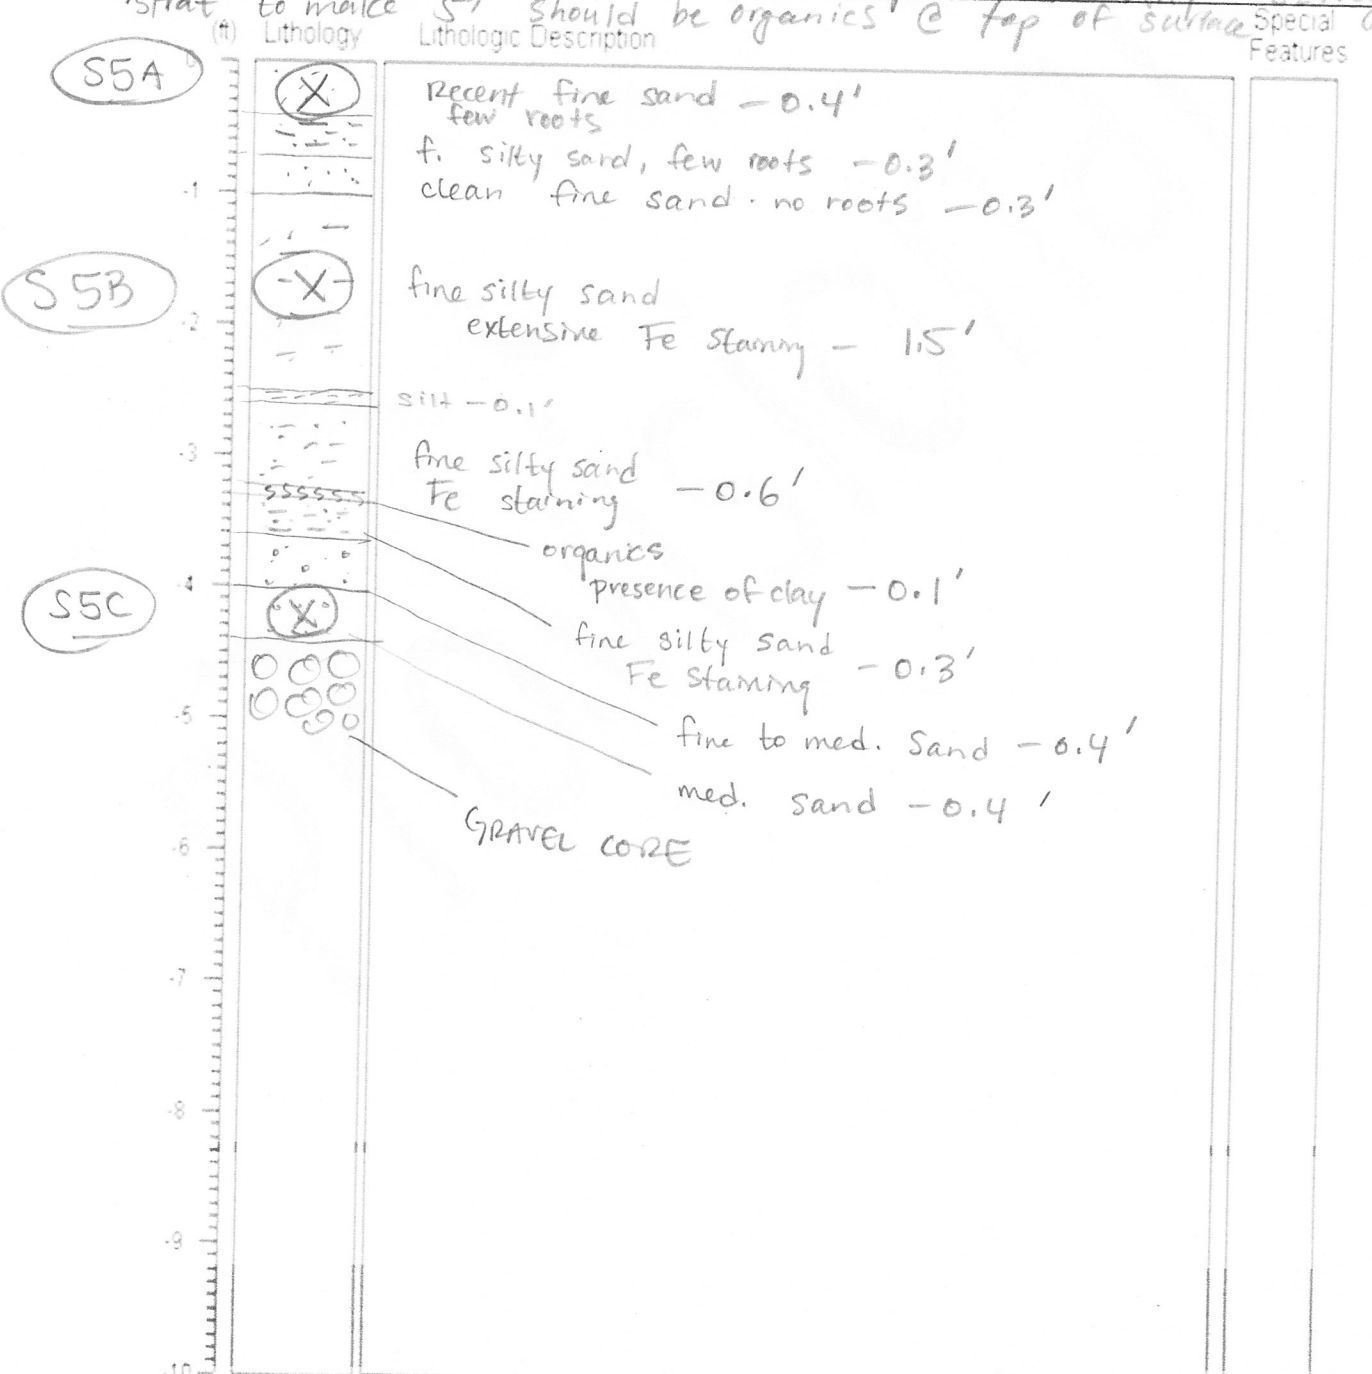
MFP surface → poplars Ø ~1', tall spruce, thick underbrush
 Gravel core should be @ 5' below top of bank. Any missing strat to make 5' should be organics @ top of subma
